## 4-H Centers: Rock Eagle and Wahsega

Two of Georgia's 4-H centers—Rock Eagle and Wahsega—are addressed herein as part of the University of Georgia Preservation Master Plan. These two properties are discussed together in this section.

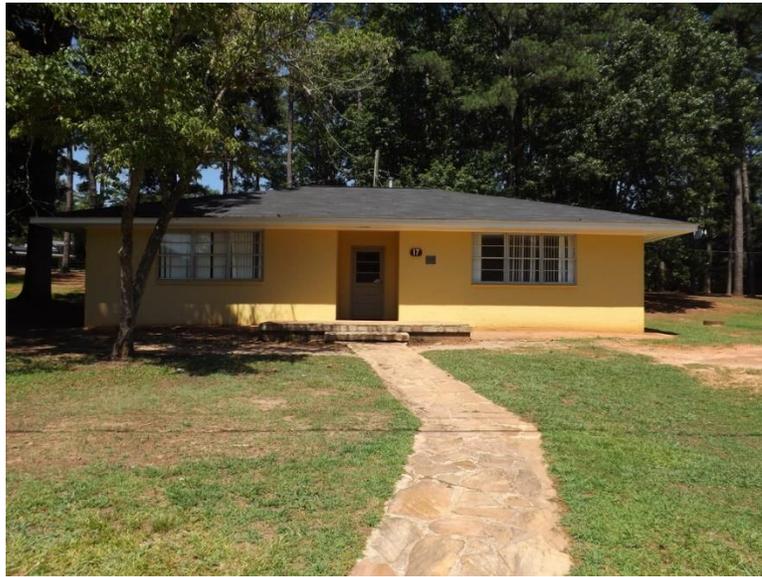
Figure 446. Cottage 17.

The cottages are single-story, concrete-unit-masonry structures with concrete foundations and low-pitched hipped roofs clad with asphalt shingles. The roofs have large overhanging eaves and vent pipes. The cottages, which are painted a variety of bright colors, have a central recessed entry marked by a single door in the center, with another on the side. Both doors feature three horizontal lights and three panels. There is also a large bay with three two-over-two metal double-hung sash windows on either side of the entry, and a large concrete sill under each window bay. A concrete walkway leads to each cabin where there is a rough stone landing, or a concrete stoop, at the front entrance. The walkways are contemporary additions. The right side elevation of each structure has three two-over-two windows and a solid metal door. The left side elevations have a single bay of paired two-over-two double-hung sash windows and a single solid door at the mounded entry. The rear elevation has two sets of paired double-hung sash windows and two single double-hung sash windows.<sup>571</sup>

Cottages surviving from the early period of development generally retain sufficient integrity to convey their historic associations and likely contribute to a National Register-eligible historic district. As such, they are assessed as Category 2 resources.

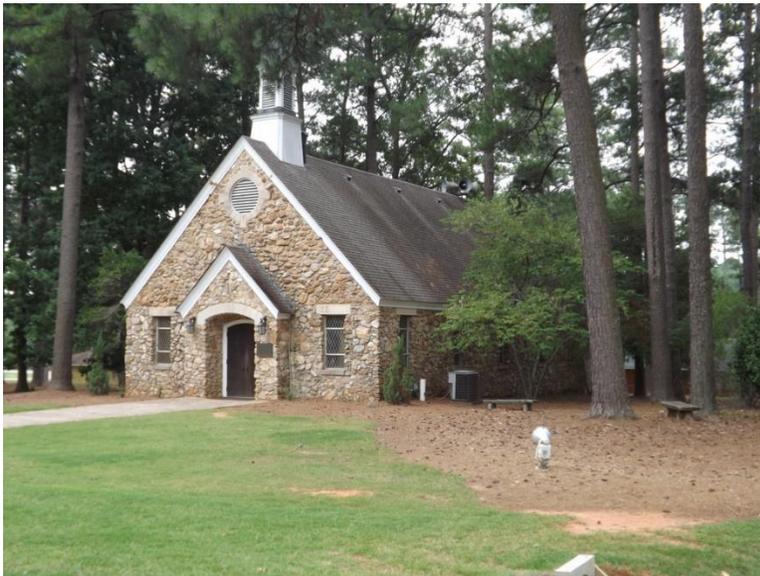
Figure 447. Chapel.

The Rock Eagle 4-H Chapel generally retains sufficient integrity to convey its historic associations and likely contributes to a National Register-eligible historic district. As such, it is assessed as a Category 2 resource.

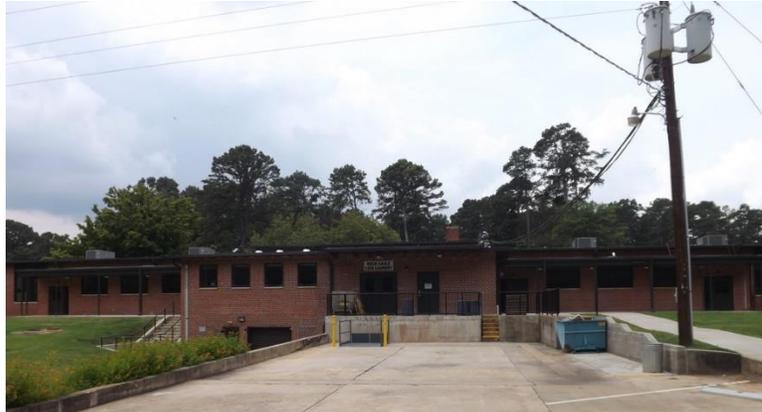
Figure 448. The dining hall.

***Dining hall – UGA 5056 (1955, Category 2).*** The dining hall is located along a quadrangle fronted by a grassy area and several sidewalks. The building is a single-story brick structure with a low-pitched or flat roof. The principal facade is symmetrical, with recessed wings on both sides. Each wing has numerous tall fixed windows with concrete sills on all three facades. The central block has paired metal doors at each end and a large bay of near floor-to-ceiling windows. The roof has large overhanging eaves with exposed metal rafters. There is a large concrete patio in front of the building. The rear facade has seven doors and a garage door at a sunken loading dock. Windows at the rear are single fixed units with concrete sills, are much smaller than the windows at the front, and have been infilled. The two rear stoops have flat roofs supported by round metal posts and metal eaves. The roof has three distinct levels.<sup>573</sup>

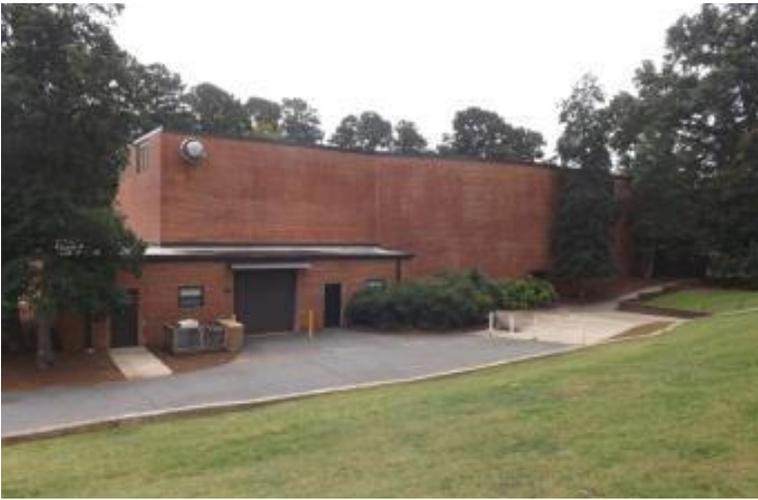
Figure 449. Talmadge Auditorium

The Talmadge Auditorium generally retains sufficient integrity to convey its historic associations and likely contributes to a National Register-eligible historic district. As such, it is assessed as a Category 2 resource.

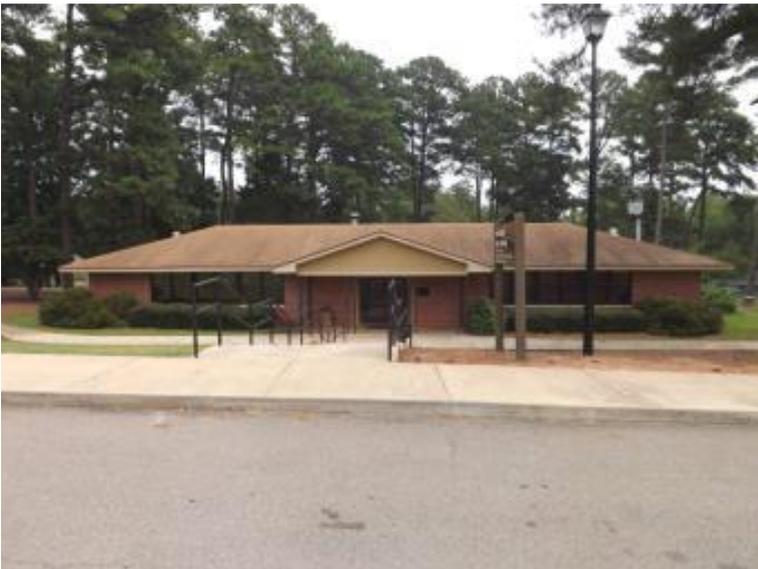
Figure 450. Union Camp Building.

The Union Camp Building generally retains sufficient integrity to convey its historic associations and likely contributes to a National Register-eligible historic district. As such, it is assessed as a Category 2 resource.

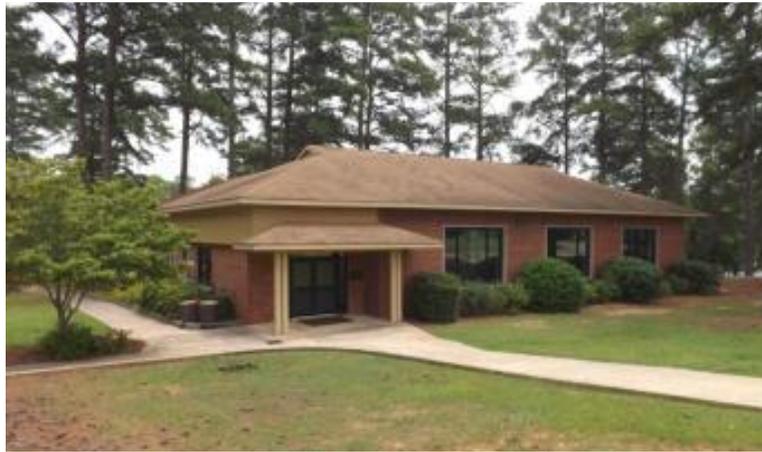
Figure 451. The Hastings Building.

***Hastings Building – UGA 5059 (1954, Category 2).*** The Hastings Building, set in the center of the complex, is a single-story brick structure with a hipped roof. There is also an overhanging eave associated with the right side of the building. The recessed entry, which is set on the left side, has flanking three-light sidelights and a single light transom, and single light aluminum framed double entry doors. Three bays of asymmetrical six-light windows are on the front and rear facades. There is also a vinyl hip-roof addition to the right rear facade. The rear entry is approached via a series of concrete steps.<sup>575</sup>

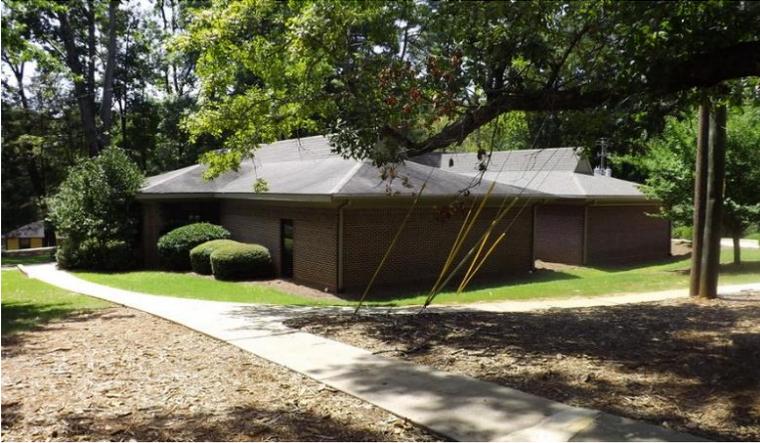
Figure 452. The Georgia Power Building.

**Georgia Power Building – UGA 5062 (1971, Category 4).** The Georgia Power Building is located between the two rows of cabins numbered 1 through 12, and 13 through 18. It is a single-story brick structure with a complex roof line composed of hipped and gabled sections and a steeply pitched section at the very top gables, with shallower hipped section. The front has a paired-door entry projecting from the facade, a transom, and side lights. Windows flank the doorway, and are located to the sides of the entry. There are also large fixed windows at both ends of front facade. The roof has overhanging eaves, with decorative brick work just below roofline. The left facade has an ell section with a rear patio and three entry doors. The rear ell has a recessed entryway with two doors. The right facade has a U-shape with one door.<sup>576</sup>

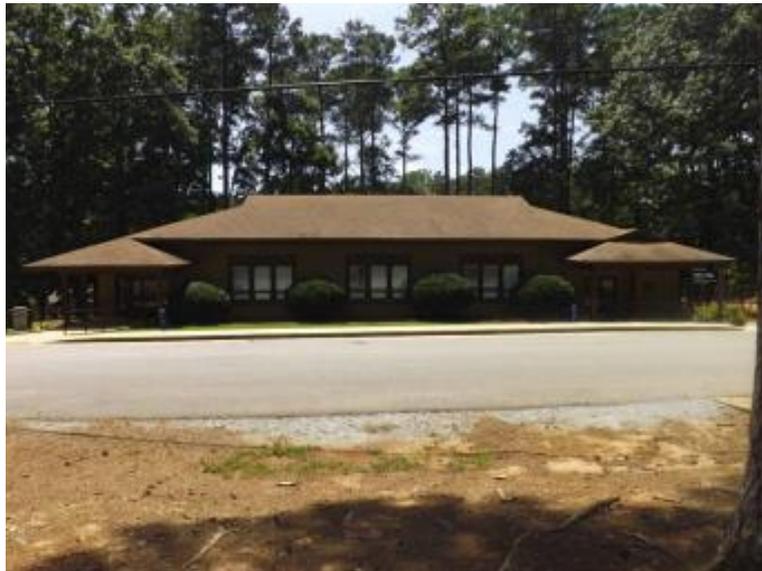
Figure 453. The Callaway Building.

The Callaway Building generally retains sufficient integrity to convey its historic associations and likely contributes to a National Register-eligible historic district. As such, it is assessed as a Category 2 resource.

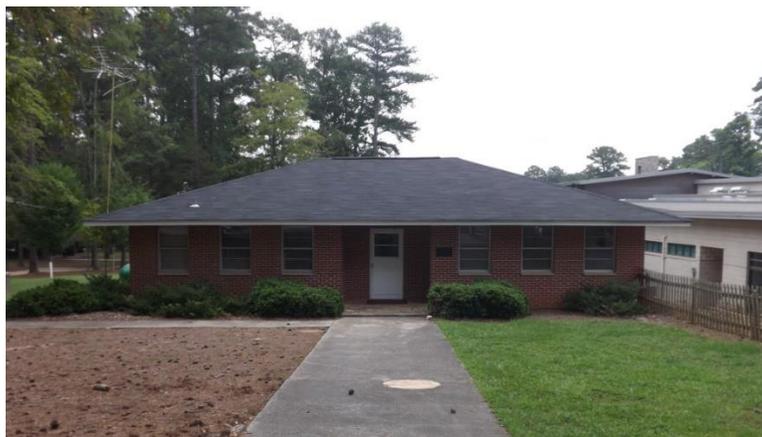
Figure 454. The Health Building.

The Health Building generally retains sufficient integrity to convey its historic associations and likely contributes to a National Register-eligible historic district. As such, it is assessed as a Category 2 resource.

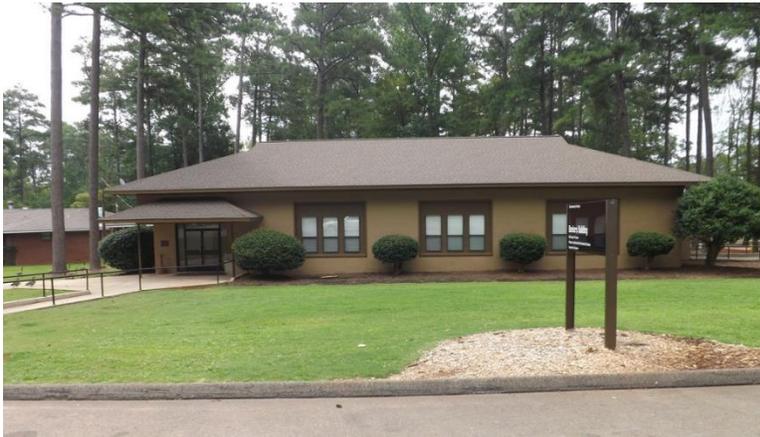
Figure 455. The Bankers building.

**Bankers Building – UGA 5066 (1953, Category 2).** The Bankers Building is located adjacent to the Health Building. This single-story yellow-brick structure has a hipped roof with large overhanging eaves, a four-bay front facade, and an entry on the left side set beneath a separate overhanging hipped roof supported by metal posts and beams. A concrete walk provides access to the entrance, which features paired two-light metal framed doors, each with a single sidelight and a transom. Three large window bays appear to be infilled. Each has three, one-over-one single-hung sash windows with metal frames. An ell on the rear has an elevated concrete patio and doorway. The left facade has two six-over-six single-hung sash windows and paired four-light jalousie windows with metal frames. This building appears to have undergone extensive renovations.<sup>579</sup>

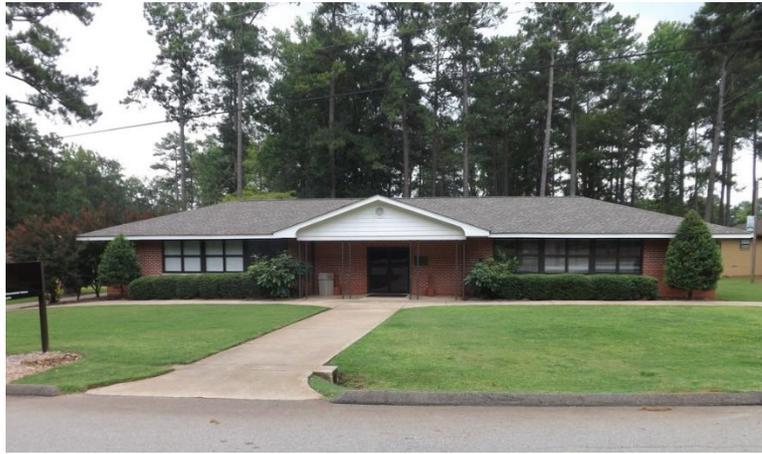
Figure 456. The Krannert Building.

The Krannert Building generally retains sufficient integrity to convey its historic associations and likely contributes to a National Register-eligible historic district. As such, it is assessed as a Category 2 resource.

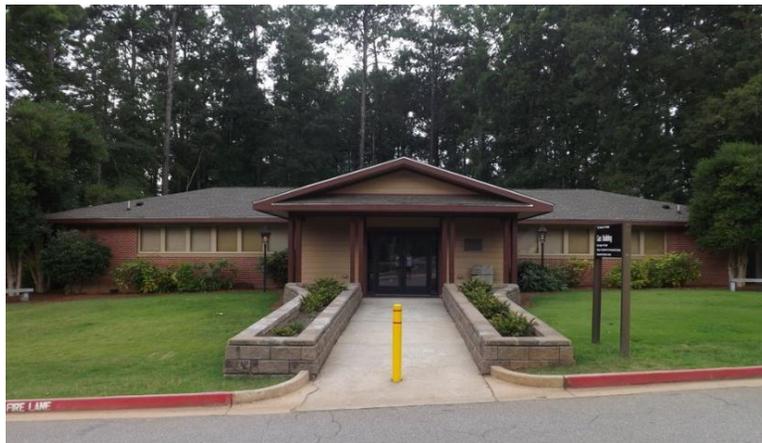
Figure 457. L.P. Gas Building.

***L.P. Gas Building – UGA 5068 (1953, Category 2).*** The L.P. gas building is a single-story brick structure with a hipped roof. The principal facade features a modern vinyl gabled portico entry with aluminum framed double doors and fixed single panel sidelights and paired wooden supports. LFSP ribbon windows flank the entry in the front facade. Gaslights also flank the entrance. A large open-air picnic area addition is located to the rear right with a brick foundation, concrete

The L.P. Gas Building generally retains sufficient integrity to convey its historic associations and likely contributes to a National Register-eligible historic district. As such, it is assessed as a Category 2 resource.

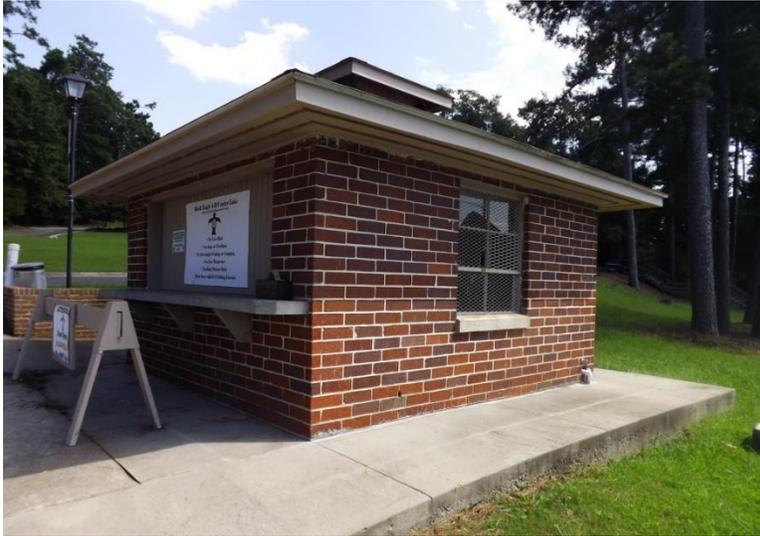
Figure 458. The Boathouse and Store.

***Boathouse and Store – UGA 5070 (1953, Category 2).*** The Boathouse and Store is a single-story brick structure with a wooden cupola and hipped roof with overhanging eaves. The building has a mid-century aluminum entry door. There are six-light windows on the left and right facades, and a vertical board concession window on the rear facade with a concrete counter. A brick retaining wall edges a concrete landing that surrounds the building to the right. Concrete bench seating is located to the rear.<sup>582</sup>

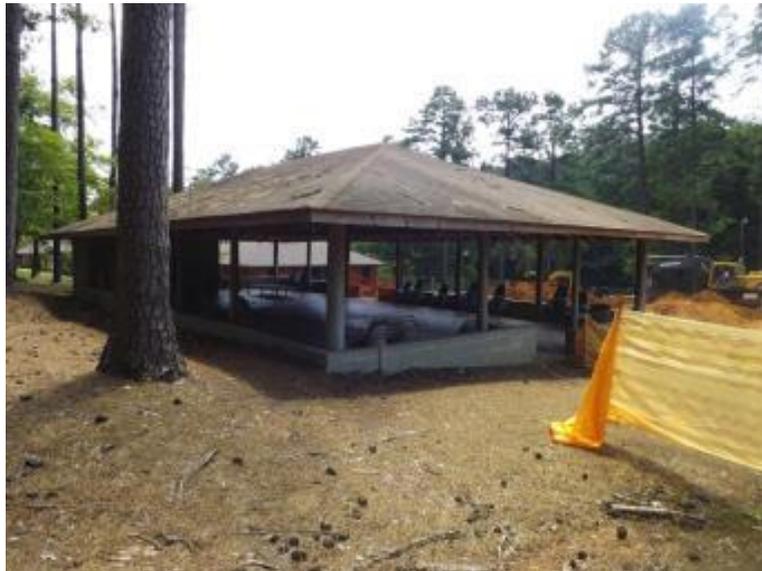
Figure 459. Pavilion 1.

Pavilion 1 generally retains sufficient integrity to convey its historic associations and likely contributes to a National Register-eligible historic district. As such, it is assessed as a Category 2 resource.

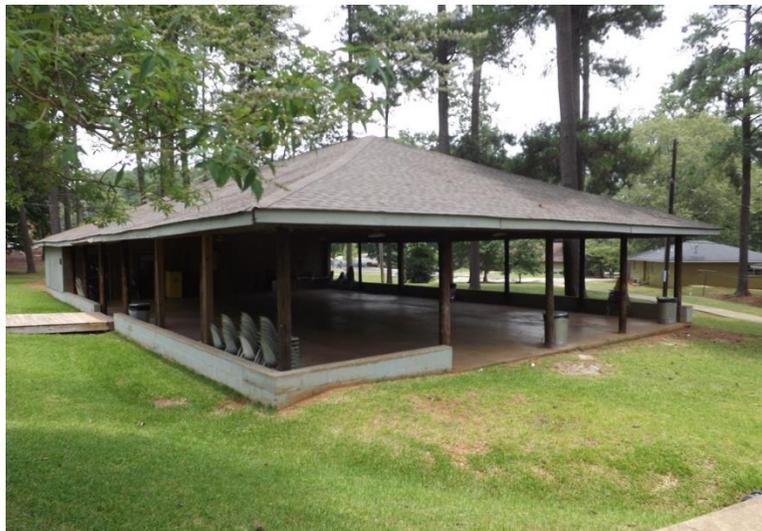
Figure 460. Pavilion 2.

Pavilion 2 generally retains sufficient integrity to convey its historic associations and likely contributes to a National Register-eligible historic district. As such, it is assessed as a Category 2 resource.

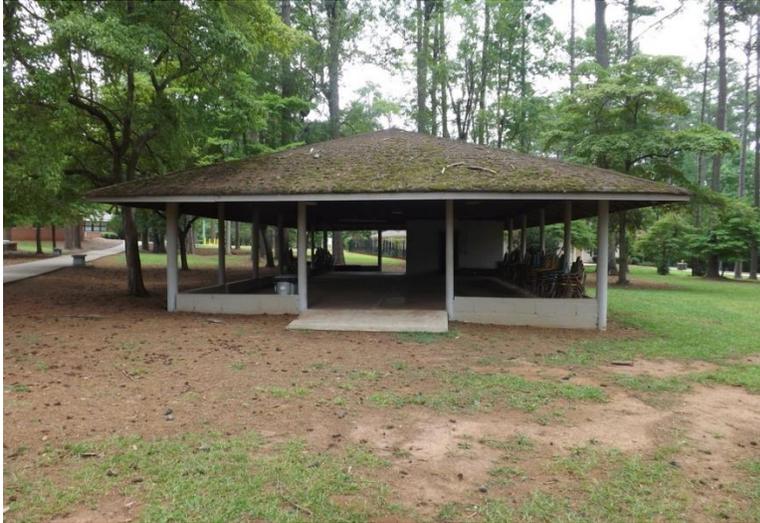
Figure 461. Pavilion 3.

***Pavilion 3 – UGA 5077 (1963, Category 2).*** The open-air Pavilion 3 has timber posts and dimensioned lumber beams and rafters, with overhanging eaves. A 2-foot-tall concrete unit masonry wall is set around the perimeter, except where a concrete ramp provides access to the interior. There is also a concrete unit masonry-enclosed room at the rear accessed by a single doorway.<sup>585</sup>

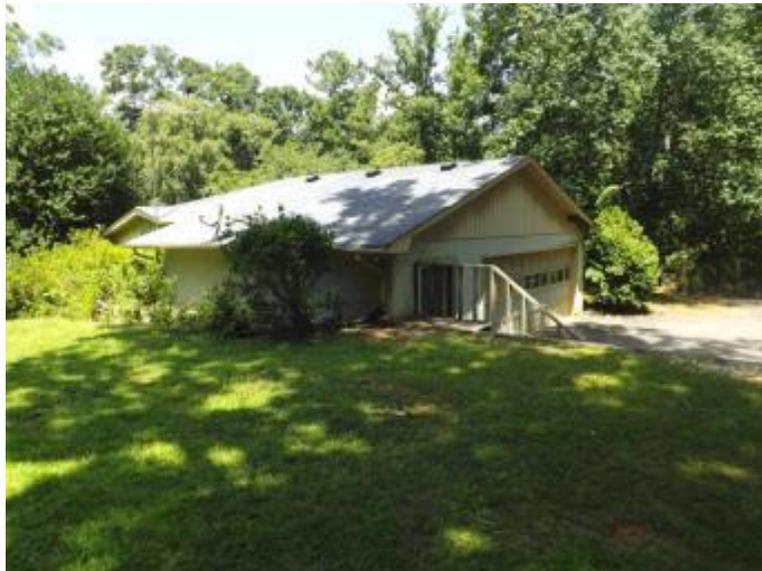
Figure 462. The Resident Williamson Building.

***Resident Williamson Building – UGA 5080 (1954, Category 2).*** The single-story wood-framed Williamson residence has three window bays, a paired one-over-one, and three one-over-one with louvered shutters. There are small ventilation holes at the bottom of the front facade. The garage forms an ell on the left with two one-over-one windows, a large garage door, and a solid entry door. There is a concrete patio at the rear ell, with an entry door and one-over-one windows. Wooden steps at the back of the driveway lead to an elevated yard. The gable of the garage is finished with stucco and vertical wood. The right facade has two one-over-one windows. Previous damage to the stucco has been repaired with plywood, although patches of stucco are still missing.<sup>586</sup>

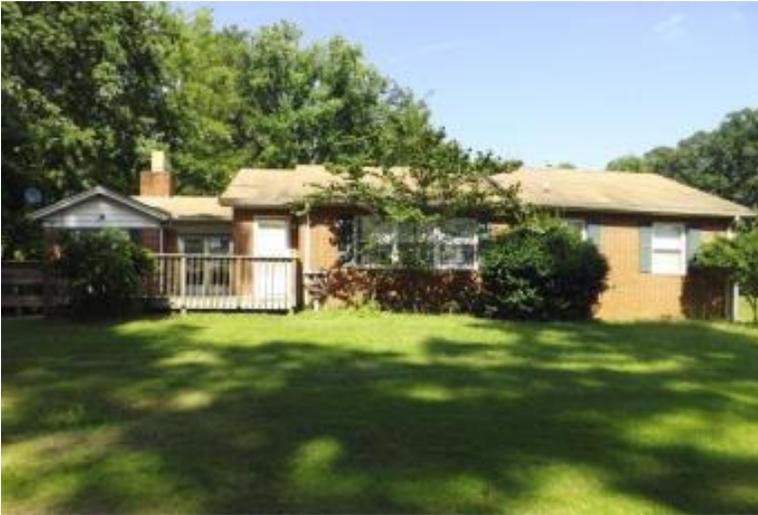
Figure 463. The Resident Jenkins building.

The Resident Jenkins Building generally retains sufficient integrity to convey its historic associations and likely contributes to a National Register-eligible historic district. As such, it is assessed as a Category 2 resource.

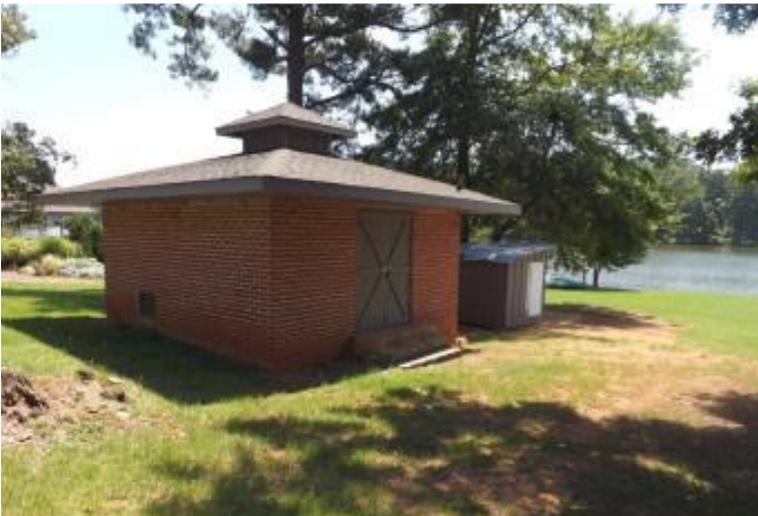
Figure 464. Pool 1 Filter House.

***Pool 1 Filter House – UGA 5082 (1952, Category 2).*** The Pool 1 filter house is a small, square, single-story brick building with a hipped roof and cupola. The roof has large overhanging wood eaves. There are wood vents with brick sills on all non-entry facades. Three cast concrete steps lead to a wood double-door entry. The left facade has a 1 by 2 foot hole in the exterior.<sup>588</sup>

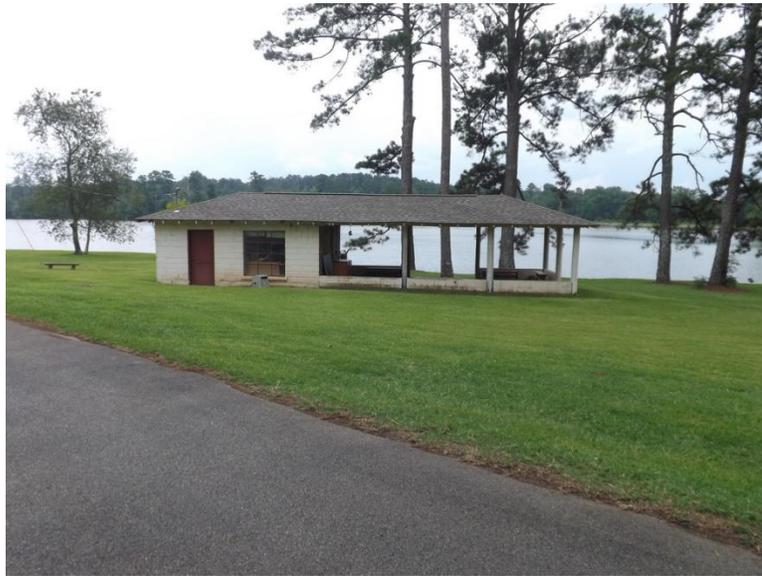
Figure 465. Senior Pavilion.

The senior pavilion generally retains sufficient integrity to convey its historic associations and likely contributes to a National Register-eligible historic district. As such, it is assessed as a Category 2 resource.

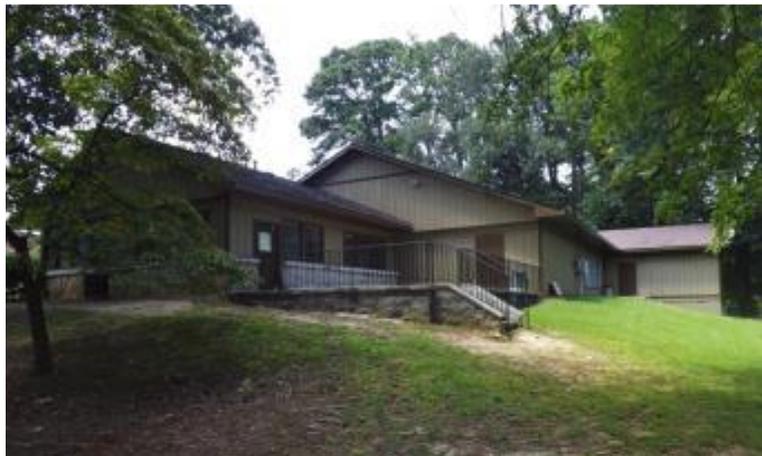
Figure 466. The Patricia Nunn Barkuloo Conference Center.

structure with three sections—a central entry pavilion, an ell, and a rear extension. Both ends of the building feature decorative, 3-foot-tall stone foundations. The central entry pavilion has a gable roof. Entry walkways flank the front door and lead to side entries. The right facade has six fixed windows. The ell features fixed windows and a wood paneled door. It is edged by a concrete patio. The rear extension features a bay of fixed windows and protruding projecting addition with a concrete masonry unit base.<sup>590</sup>

The Patricia Nunn Barkuloo Conference Center postdates the period of significance and is non-contributing. It is more than 40 years old, however. As such it is assessed as a Category 4 resource.

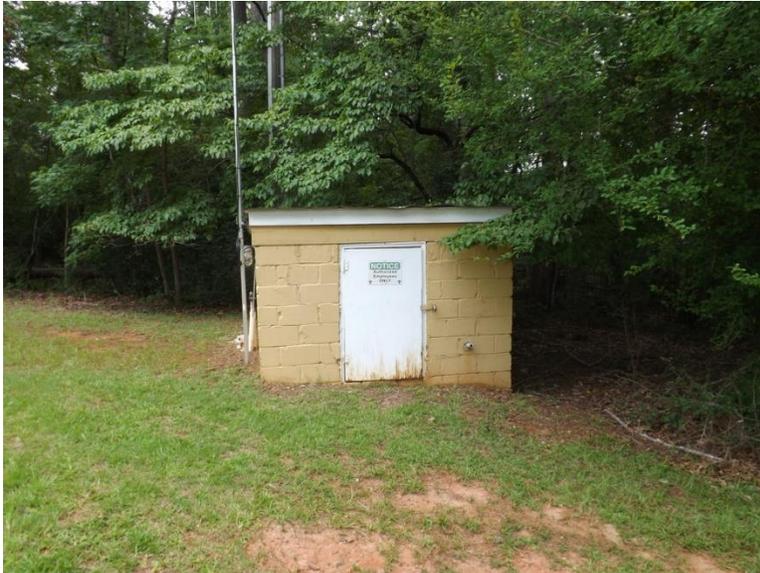
Figure 467. The pump house.

***Pump House – UGA 5089 (1953, Category 2).*** The pump house is a concrete unit masonry structure painted yellow with a 3-foot-wide wooden door on the front facade. The building has a shed roof and wood eaves. There is a metal light cage at the side facade and PVC pipe at the left facade.<sup>591</sup>

The pump house generally retains sufficient integrity to convey its historic associations and likely contributes to a National Register-eligible historic district. As such, it is assessed as a Category 2 resource.

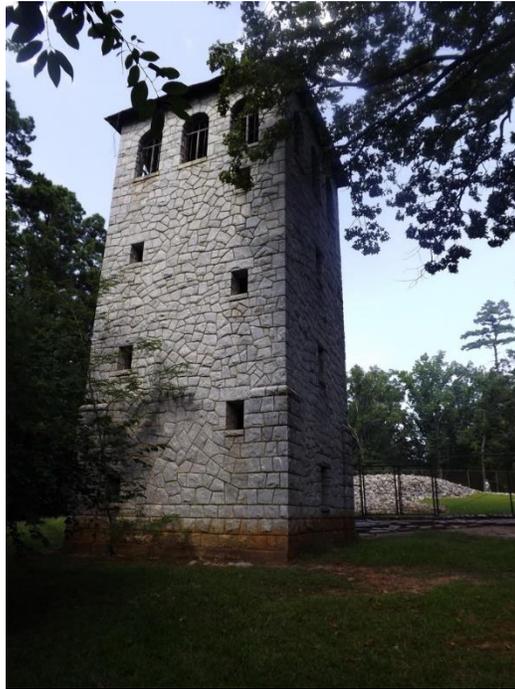
Figure 468. The observation tower.

The observation tower generally retains sufficient integrity to convey its historic associations and appears individually eligible for listing in the National Register of Historic Places. As such, it has been assessed as a Category 1 resource.

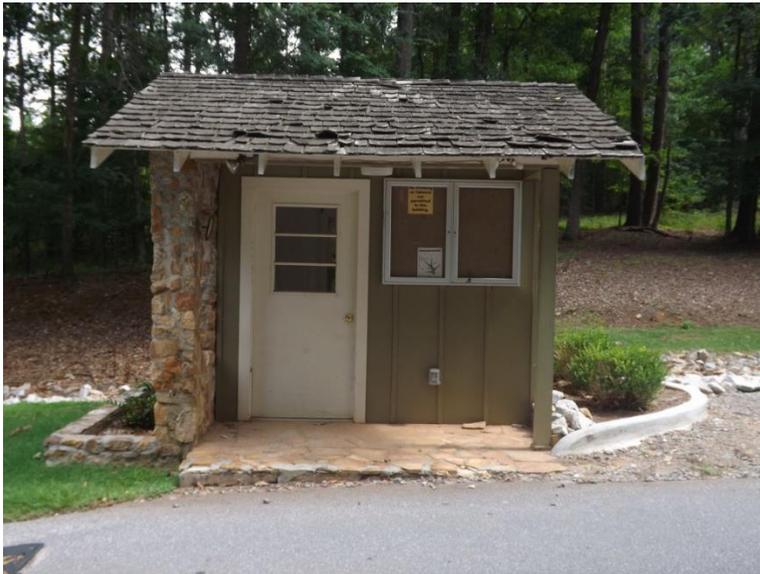
Figure 469. The gate house.

***Gate house – UGA 5091 (1969, Category 4).*** The gate house is a modest wood-framed structure, with a rough stone pier on the right side. The gable roof is low-pitched, with exposed rafter ends and large overhanging eaves. A stone patio fronts the entrance, which features a wood door with a three-light window. Windows are two-over-two double-hung sash at the right and rear facades, and there is a single light window at the left. There are also stone planters at the base of the side facade, and cast-in-place concrete planters on the right facade. Stone pillars connected by chains edge the road to either side. A rip-rap swale is located at the rear of the structure.<sup>593</sup>

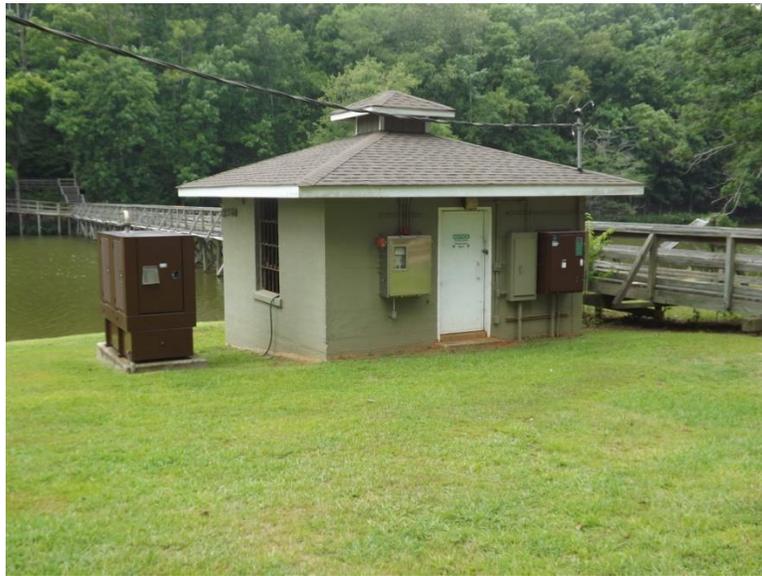
Figure 470. The Sewerage lift station.

***Sewerage lift station – UGA 5092 (1954, Category 2).*** The sewerage lift station is a small stuccoed concrete unit masonry structure with a hipped roof that features a large wooden cornice and a cupola on top. The solid metal door is set in the center of the front facade. Electrical boxes flank the door. There are unglazed, metal sash windows with concrete sills on the side facades. The square cupola has vertical board and a pyramidal roof. The lift station is set along the edge of the lake near a wooden footbridge. A large exterior electrical box is located near the right facade.<sup>594</sup>

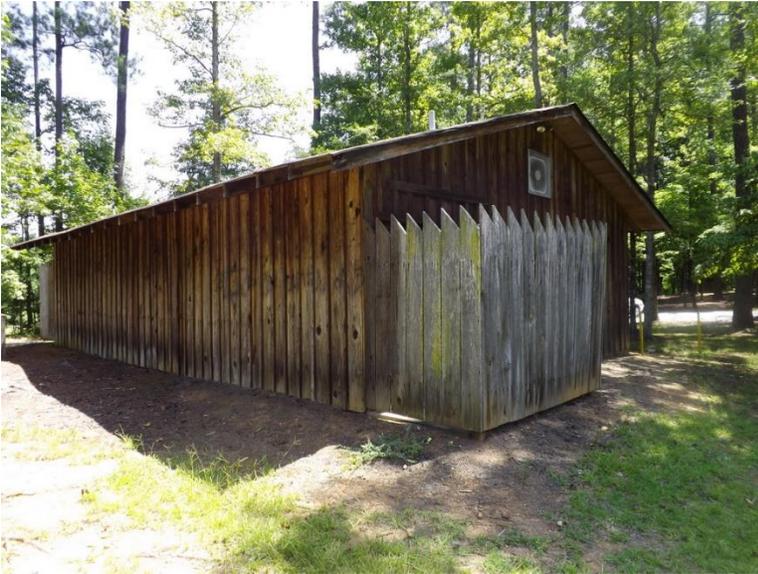
Figure 471. The Bathhouse.

The Bathhouse postdates the period of significance, and does not contribute to a National Register-eligible historic district. The bathhouse is more than 40 years of age, however. As such, it is assessed as a Category 4 resource.

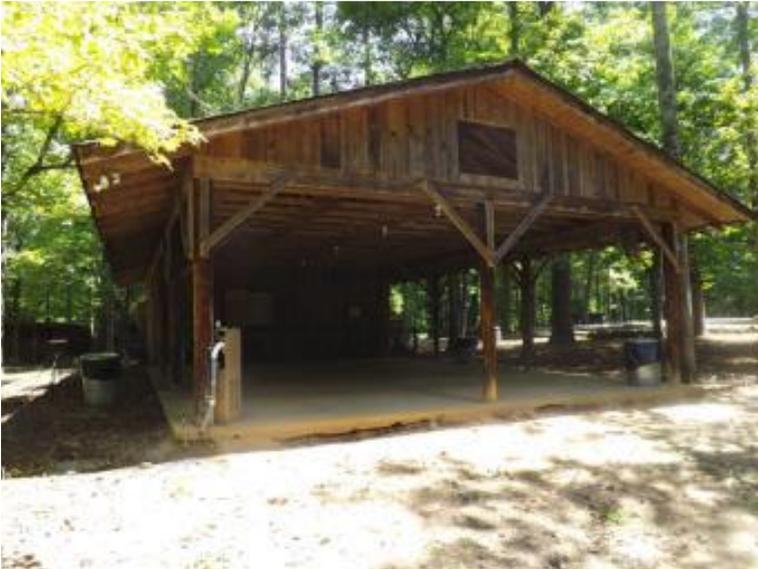
Figure 472. The Pioneer Camp Pavilion.

The Pioneer Camp Pavilion postdates the period of significance, and does not contribute to a National Register-eligible historic district. The pioneer camp pavilion is more than forty years of age, however. As such, it is assessed as a Category 4 resource.

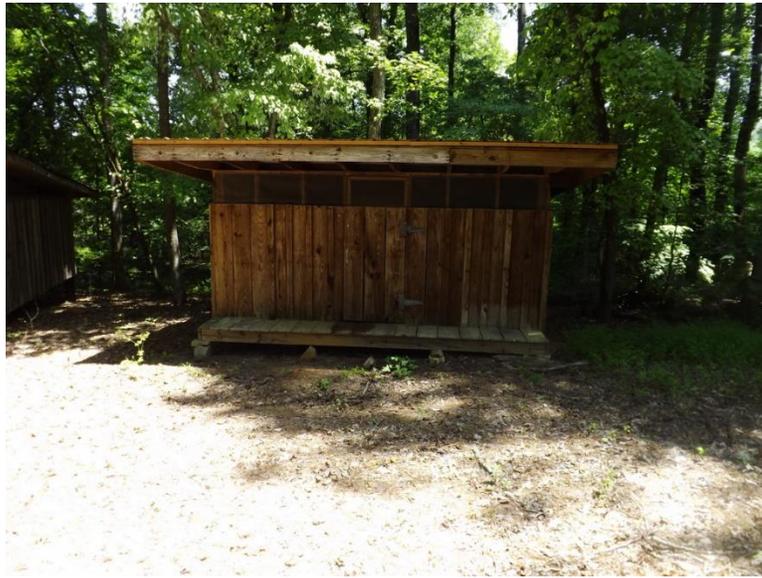
Figure 473. Adirondack Cabins.

***Pioneer Camp Adirondack Cabins 1 through 9 – UGA 5098 (1972, Category 4).*** This cluster of cabins serves the pioneer camp. It includes nine, rustic, one-room wooden structures, eight of which are rectangular with small covered porch entrances, shed roofs, exposed posts, and screened areas below the rooflines. The ninth cabin is an A-frame structure with overhanging eaves, a screen door, and board and batten siding. Two of the cabins are in disrepair, with evidence of roof damage. The foundations are stone or concrete piers.<sup>597</sup>

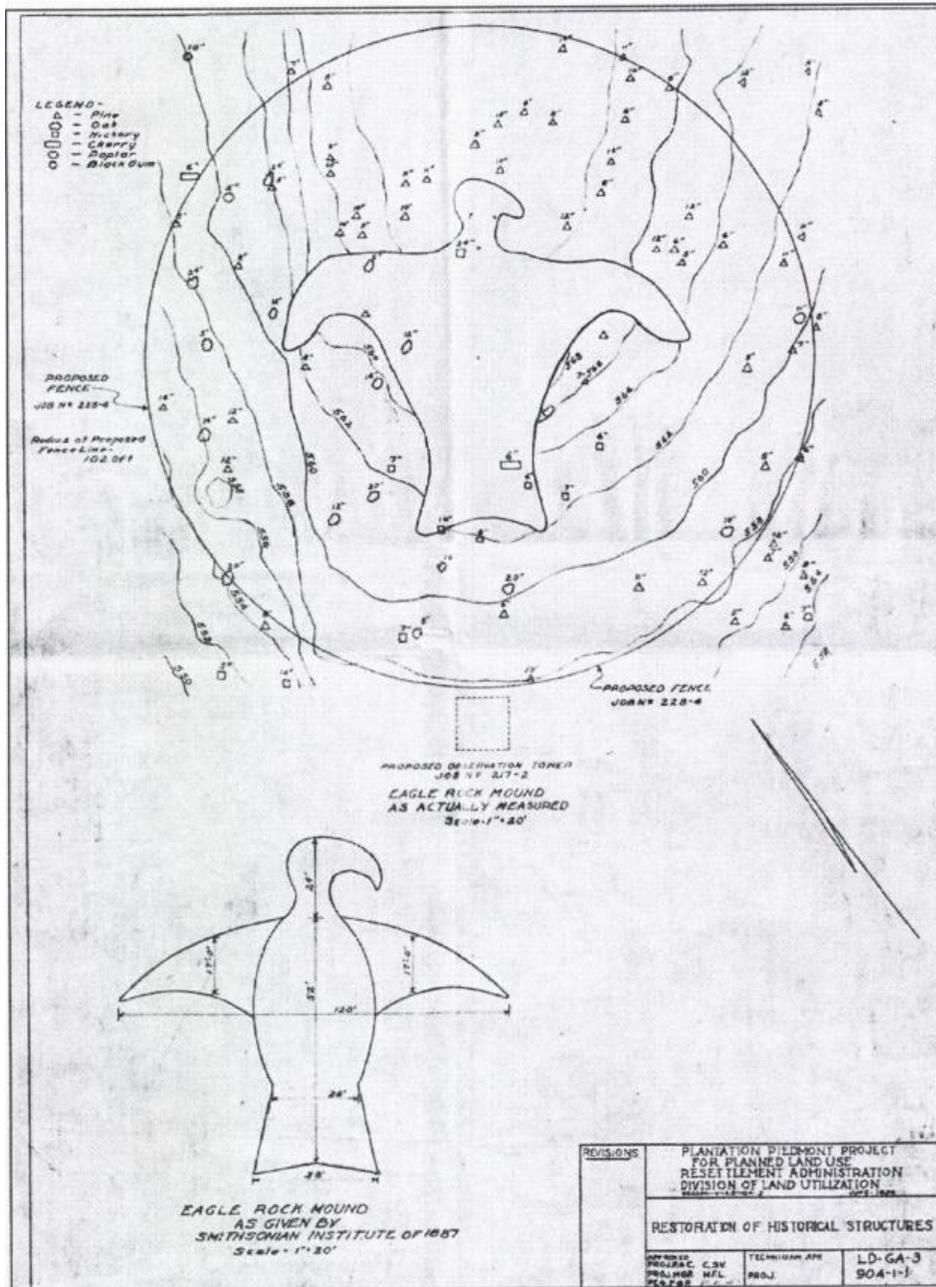
Figure 474. Drawing for restoration of Rock Eagle mound, 1936. (Source: University of Georgia archives)

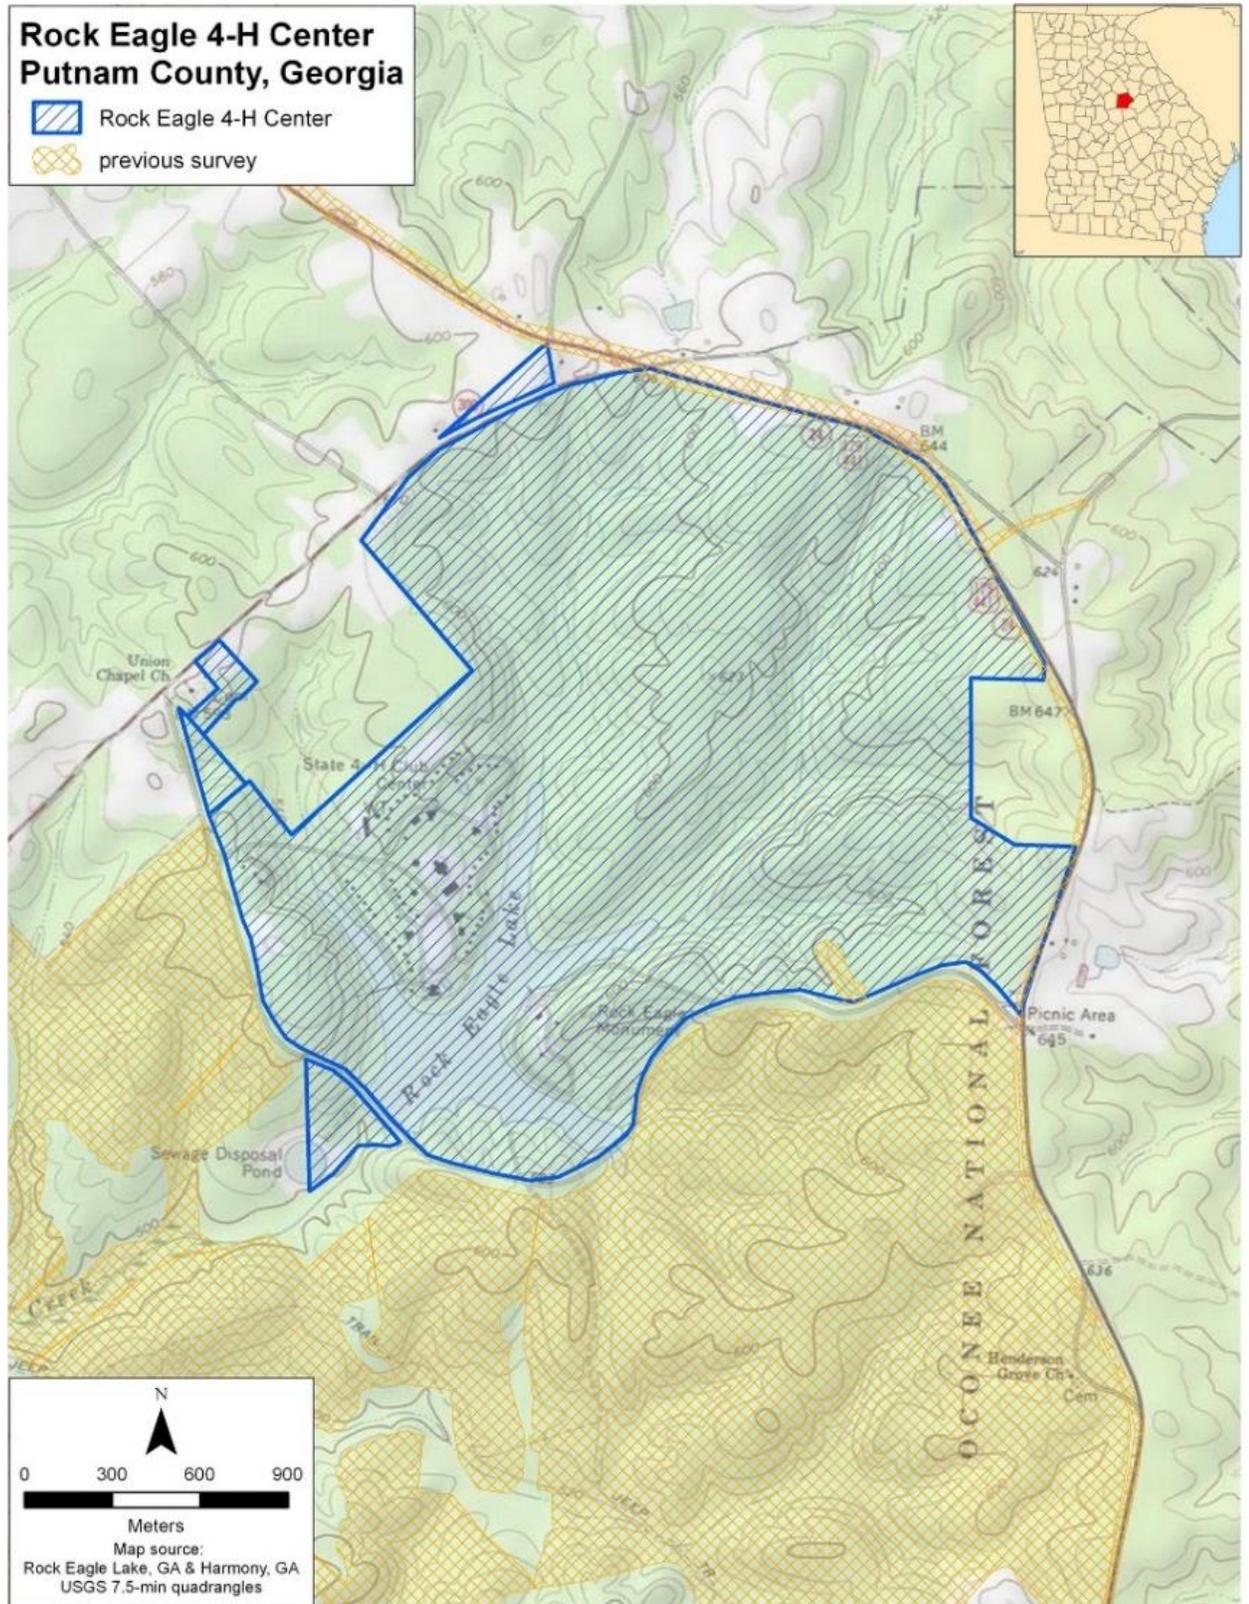
Figure 475. Rock Eagle 4-H Center property and area of previous archaeological survey. (Source: USGS, annotated by the authors.)

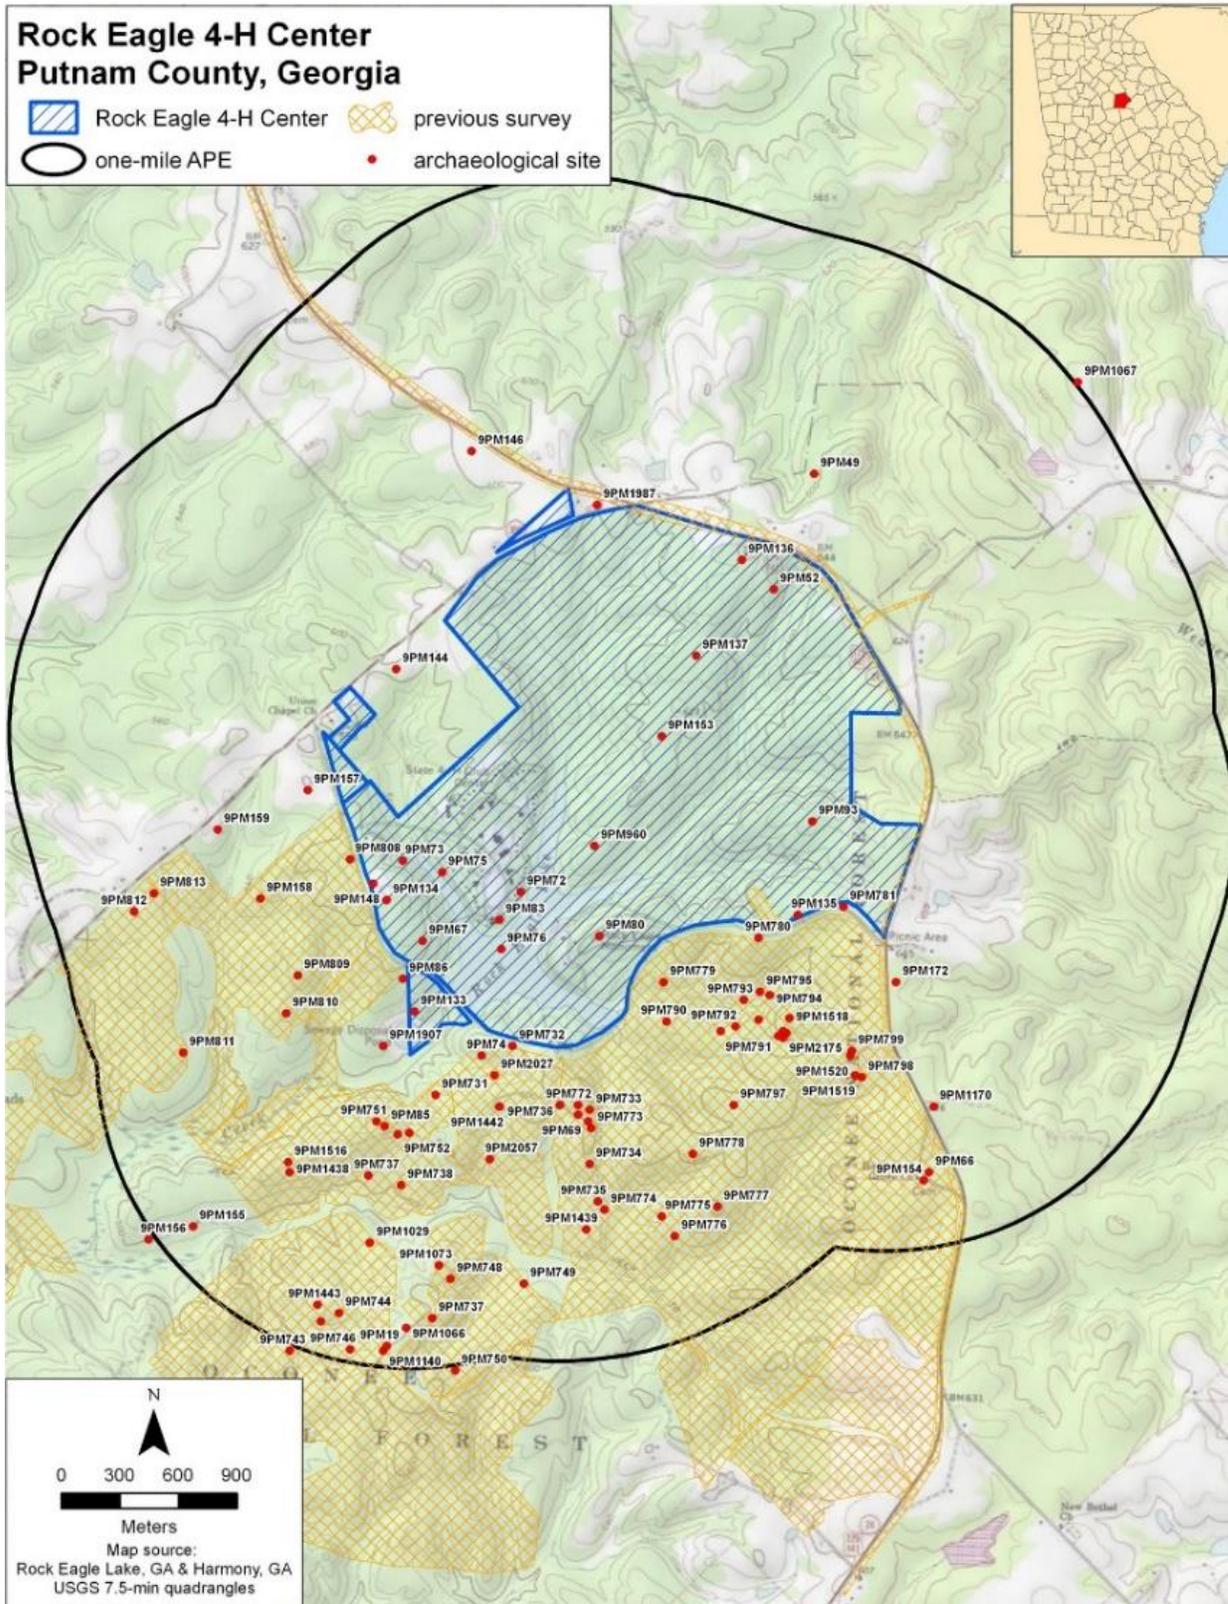
Fig. 477. Rock Eagle 4-H Center property and area of previous archaeological survey, previously identified archaeological sites, and area of potential effects (APE). (Source: USGS, annotated by the authors)

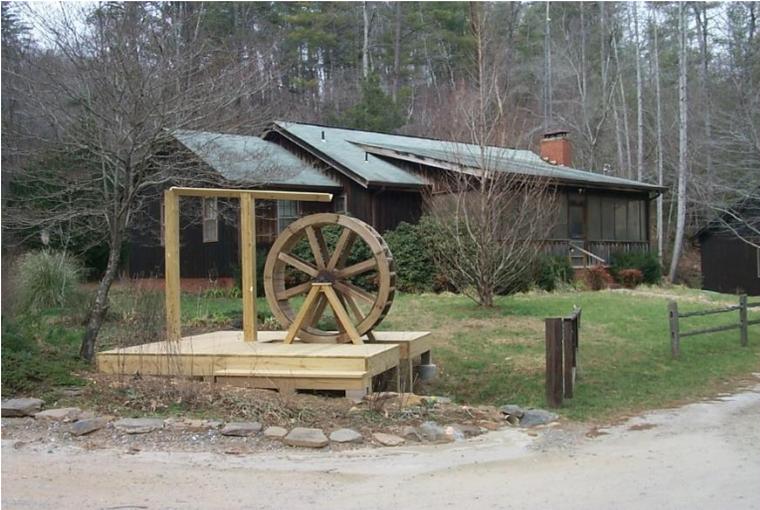
Figure 476. Manager's House/Director's House/Caretaker's House, with water wheel in foreground. (Source: University of Georgia Office of University Architects)

***Manager's House/Director's House/Caretaker's House – UGA 5318 (1938, Category 2).*** This building was the original CCC camp infirmary. It has four rooms and a central hallway, bathroom, and two closets. A screened porch extends across the back as an integral part of the structure. It has board and batten siding with stonework foundations and steps. The building measures 23 feet 6 inches by 33 feet 6 inches in plan, including the porch.<sup>603</sup> The building is believed to have been renovated in 1979.

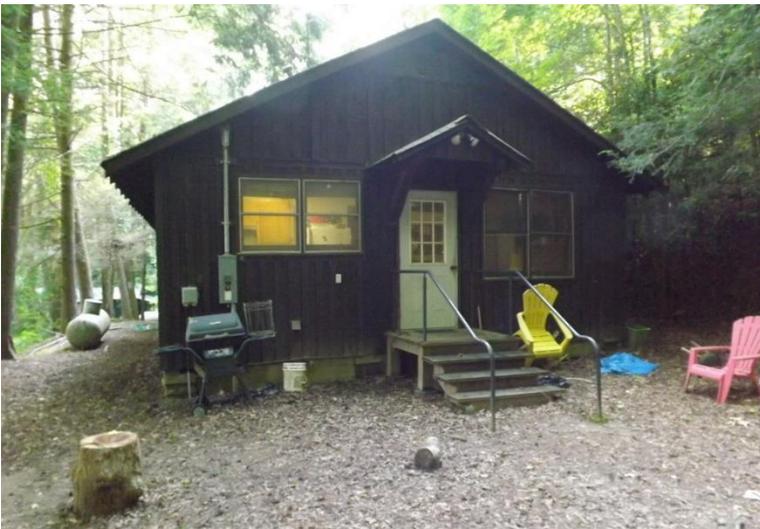
Figure 477. Camp Wahsega boy counselors' cabin.

***Camp Wahsega boy counselors' cabin – UGA 5319 (1938, Category 2).*** This wood-framed cabin has a front-gabled facade with an elevated doorway. Wooden steps with handrails lead to the central entry door. Large wooden brackets support a pediment above the door. There are two sets of one-over-one windows on either side of the door. There is also a wooden belt course above the doorway below the gable. The roof has overhanging eaves with exposed rafter ends. The foundation is concrete unit masonry infilled with plywood. The side facades

The boy counselors' cabin generally retains sufficient integrity to convey its historic associations and likely contributes to a National Register-eligible historic district. As such, it is assessed as a Category 2 resource.

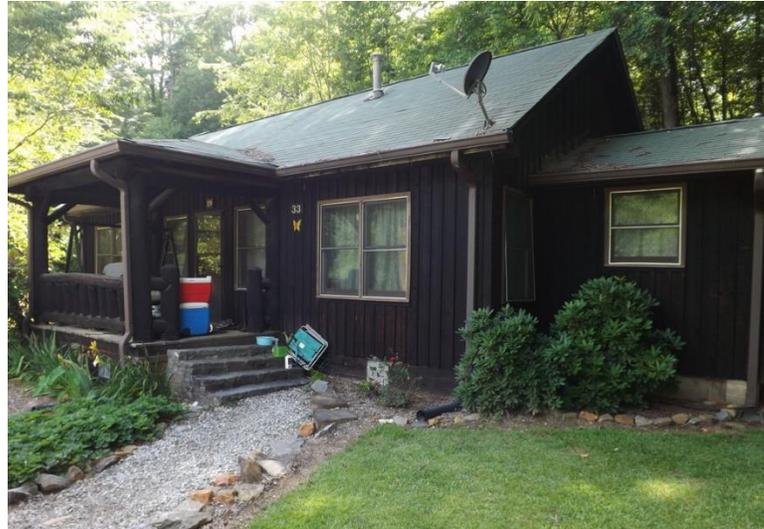
Figure 478. Camp Wahsega girl counselors' cabin.

***Camp Wahsega girl counselors' cabin/guest house – UGA 5320 (1938, Category 2).*** The guest house is located along Cloverleaf Trail north of the Director's residence. It is also located across from the basketball and volleyball courts. The building is approached via a gravel path edged with stones, and fieldstone steps lead to a wood veranda. The girl counselors' cabin/guest house is a single-story wood-frame structure with a gable roof. There is a side-gabled addition on the left. The windows are midcentury replacements with wooden frames. The roof has large overhanging eaves. The guest house contains two bedrooms, a central hallway, a small kitchen and bath, and a small porch. The structure measures 23 by 36 feet in plan. The porch is an additional 7 feet 9 inches by 12 feet 8 inches in plan, and is centered on the front door. Windows are double-hung four-over-four units. The exterior is board and batten, with peeled pole porch supports and rails, and stonework foundations and steps.<sup>604</sup> Some original stone piers have been replaced with concrete unit masonry. Other alterations include an aluminum gutter system and green asphalt shingle roof.<sup>605</sup>

Despite the noted alterations, the girl counselors' cabin generally retains sufficient integrity to convey its historic associations and likely contributes to a National Register-eligible historic district. As such, it is assessed as a Category 2 resource.
