## 4-H Centers: Rock Eagle and Wahsega

Two of Georgia's 4-H centers—Rock Eagle and Wahsega—are addressed herein as part of the University of Georgia Preservation Master Plan. These two properties are discussed together in this section.

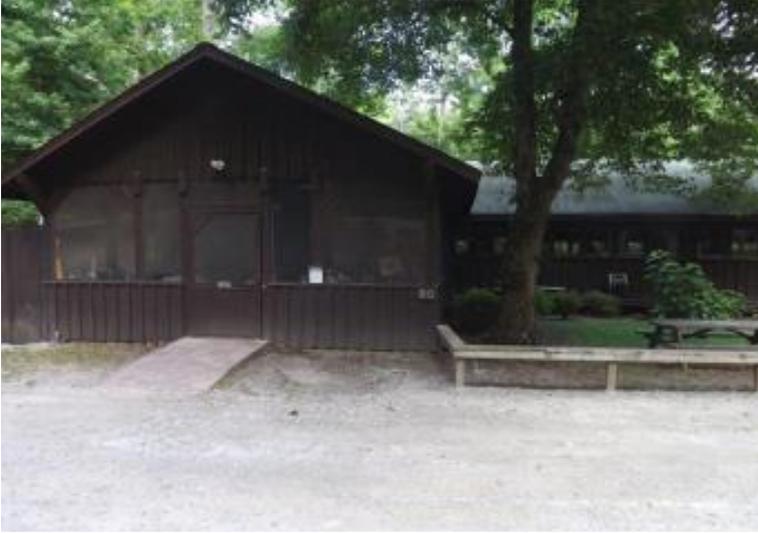
Figure 479. Camp Wahsega dining hall.

***Camp Wahsega dining hall – UGA 5321 (1938, Category 2).*** The Camp Wahsega dining hall is located across from the canteen and office/classroom building along the camp’s main road. It is edged to the north and east by streams and Ward Creek. The dining hall measures 27 feet 7 inches by 83 feet 11 inches in plan, with a 4-by-21-foot entry porch and storage room on one side that may be an addition. The building includes a dining hall with a raised stage at the end and a large stonework fireplace, a kitchen, and a storage room and bathroom. The building has a gable roof, board-and-batten siding, and stonework foundations, steps, and chimney. The principal facade has the cross gabled addition with a screened porch and storage area, a large door at ground level, overhanging eaves, and wooden brackets. Windows are top-hinged, six-light units. A later elevated entrance occurs on the far right of front facade. Both gabled ends have massive rough stone chimneys. The rear facade is also an addition. It has fourteen newer one-over-one windows. A ramp and stairs lead to a doorway near the back of the left side facade. There is a small fountain at the front facade.<sup>606</sup>

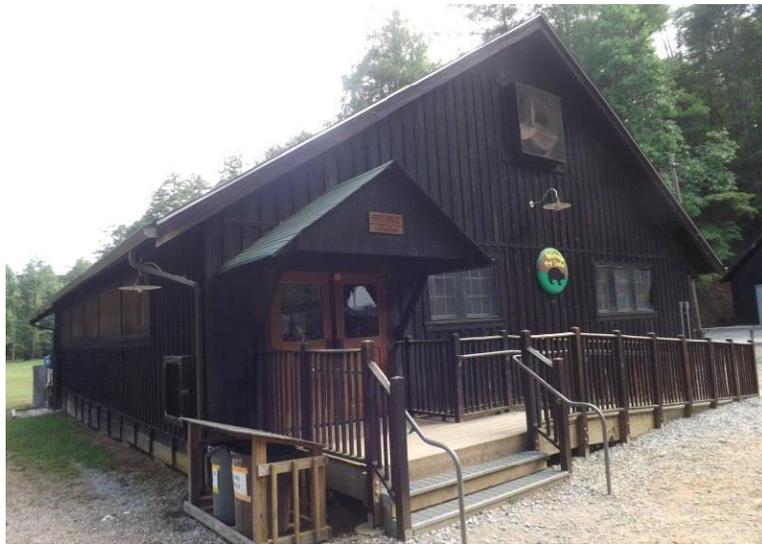
Figure 480. Recreation Hall, 2015.

***Recreation Hall (Assembly Hall) – UGA 5322 (1951, Category 2).*** The Recreation Hall (Assembly Hall) is clad with wood board-and-batten siding. The building has a gable roof clad with asphalt shingles. A contemporary stair and accessible ramp leads to the main entrance, which is marked with a wood-framed, gable-roofed awning.

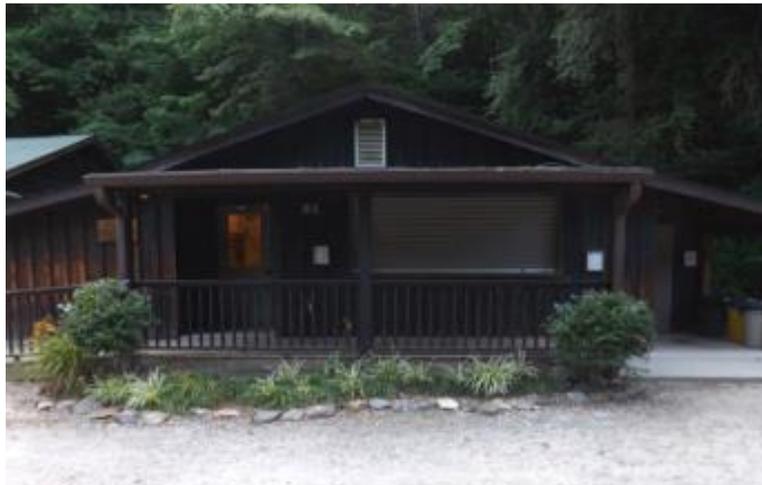
Figure 481. Camp Wahsega craft food storage building.

***Camp Wahsega craft food storage building – UGA 5324 (1938, Category 2).*** The craft food storage building faces the camp road. The front facade has seven bays with an irregular distribution of four doors and three windows. The door opens onto three unroofed porches. The porches are simple decks upheld by wooden posts. A fifth door is set on the north end. The building is four rooms wide. Some of the original novelty board has been replaced with weatherboard. Since 1975, most of the doors and some of the cladding has been replaced. Circa 1985, the porches were replaced.<sup>607</sup>

Despite diminished integrity of materials, the craft food storage building generally retains sufficient integrity to convey its historic associations and likely contributes to a National Register-eligible historic district. As such, it is assessed as a Category 2 resource.

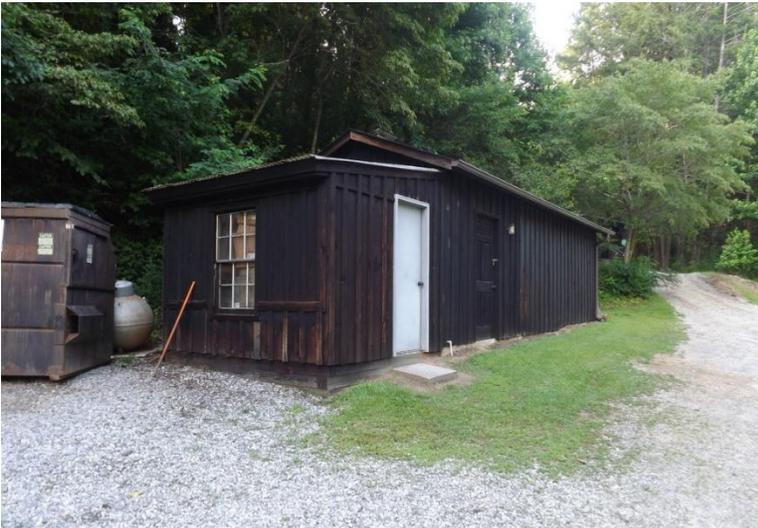
Figure 482. Camp Wahsega pump house.

***Camp Wahsega pump house – UGA 5325 (1972, Category 4).*** The pump house is low wood-framed structure with a shed addition along the front facade near the entryway and a 30-foot side gable extension. The doors and roof are mid-century replacements. The left facade has a board and batten entry door. The right facade shed addition has a single, six-over-six light window.<sup>608</sup>

The pump house postdates the period of significance, and is non-contributing. The structure is more than 40 years of age, however. As such, it is assessed as a Category 4 resource.

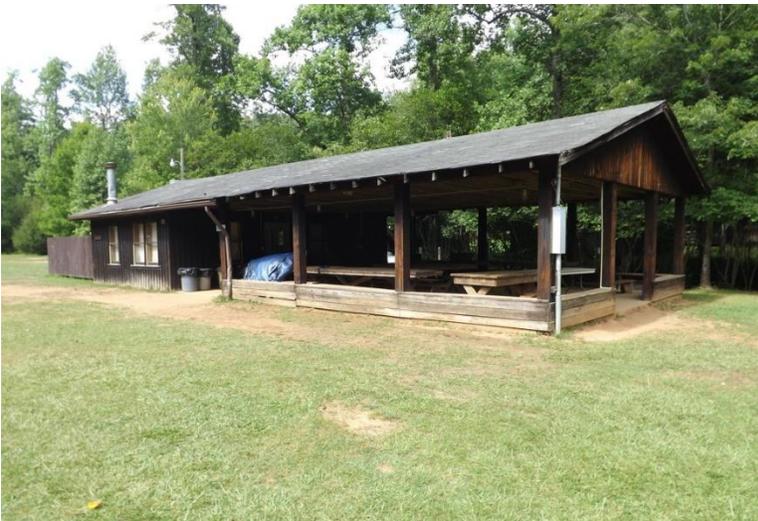
Figure 483. 4-H large pavilion.

The large pavilion generally retains sufficient integrity to convey its historic associations and likely contributes to a National Register-eligible historic district. As such, it is assessed as a Category 2 resource.

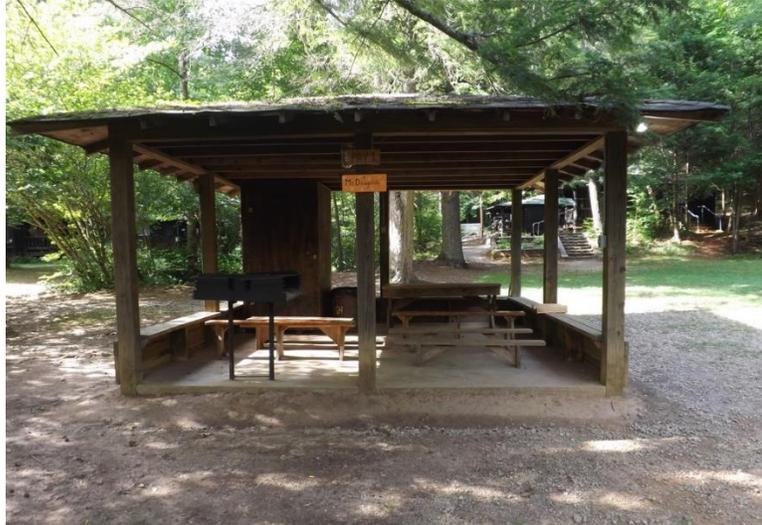
Figure 484. Camp Wahsega small pavilion 1.

**Camp Wahsega small pavilion 1 – UGA 5327 (1963, Category 2).** Small pavilion 1 is an open-air structure with a concrete floor surrounded on two sides by wooden bench seating. There are eight 8 by 8 square beams that support the pyramidal roof, which features exposed rafter tails. There is a 6-foot-tall plywood storage shed underneath the roof. There is a metal grill station at the front. It appears that most of the original materials have been replaced.<sup>610</sup>

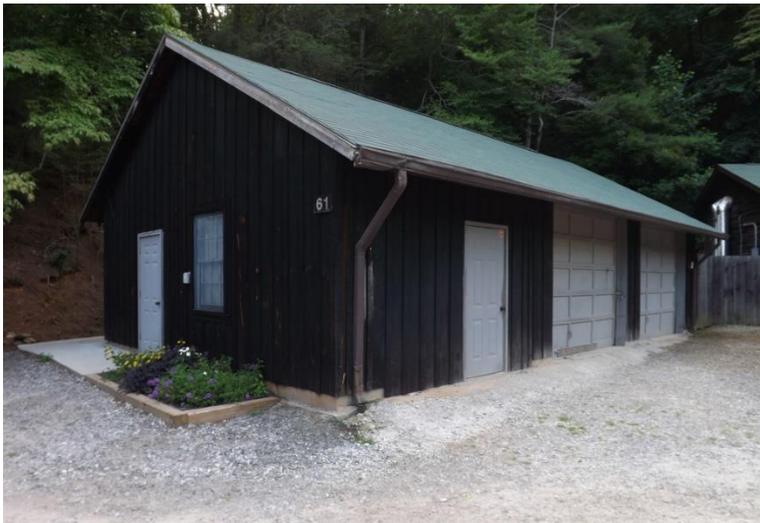
Figure 486. Camp Wahsega shop building.

***Camp Wahsega Shop Building – UGA 5330 (1975, Category 4).*** The Shop Building is a single-story structure with a gable roof and vertical board siding. A cast-in-place concrete walk leads to the front entry door, and serves as the foundation for a later, open-air addition to the right. The space serves as machinery storage. The left side of the facade has an entryway and two aluminum garage doors. These are mid-century replacements, as is the asphalt roof, which features overhanging wooden eaves.<sup>613</sup>

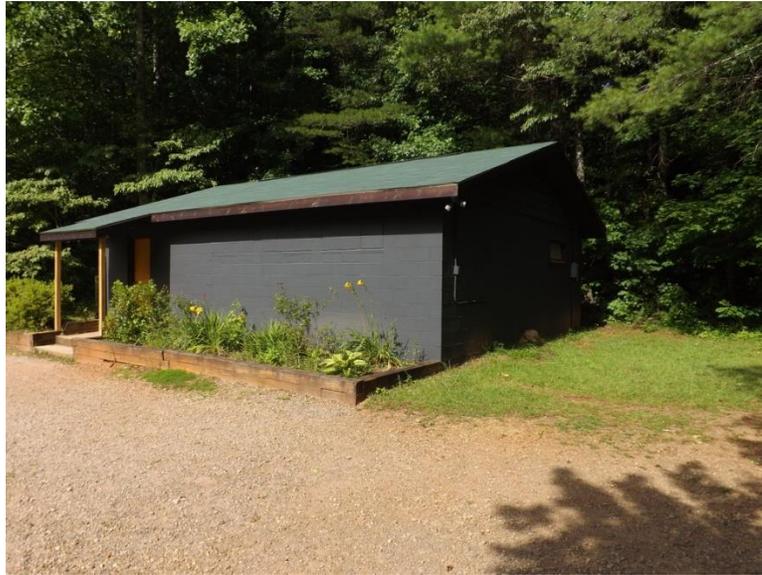
Figure 487. Camp Wahsega girls' bathhouse.

***Camp Wahsega Girls' Bathhouse – UGA 5331 (1963, Category 2).*** The original girls' bathhouse was lost to fire and rebuilt in 1963 as a concrete unit masonry structure. The current structure has concrete unit masonry infill in the windows in front and frosted jalousie windows on the rear and left facades, and three more on the right. The gable roof has wide overhanging eaves. Access is provided via two concrete steps under a shed portico extension to the front entryway. Each gable is clad with weatherboard and contains a triangular aluminum vent.<sup>614</sup>

Despite being a replacement of an earlier structure, the girls' bathhouse retains sufficient integrity to convey its historic associations and likely contributes to a National Register-eligible historic district. As such, it is assessed as a Category 2 resource.

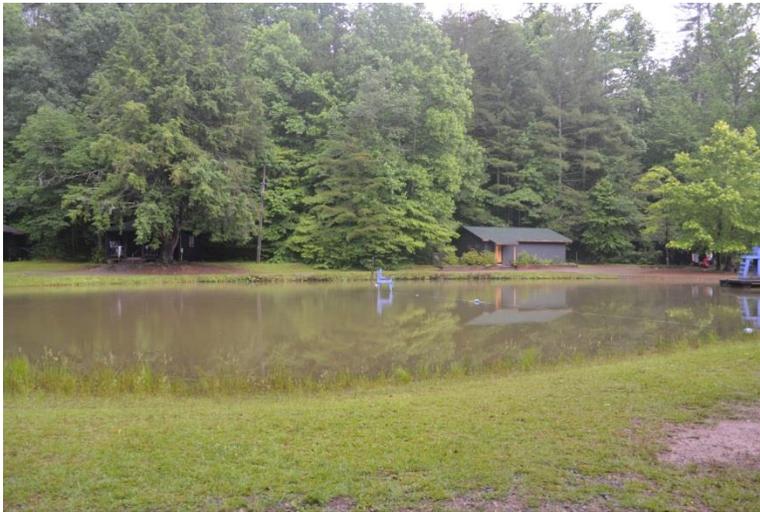
Figure 489. Swimming Pond with Girls' Bathhouse beyond.

***Swimming Pond (date undetermined, Category 2).*** The Swimming Pond was first constructed by the CCC enrollees of Camp F-11. The dam has been upgraded since the 1930s, along with the water conveyance system. Despite diminished integrity of design and setting, the swimming pond survives from the period of significance with sufficient integrity to convey its historic associations. The pond thus contributes to the significance of a potential National Register historic district. As such, it is assessed as a Category 2 resource.

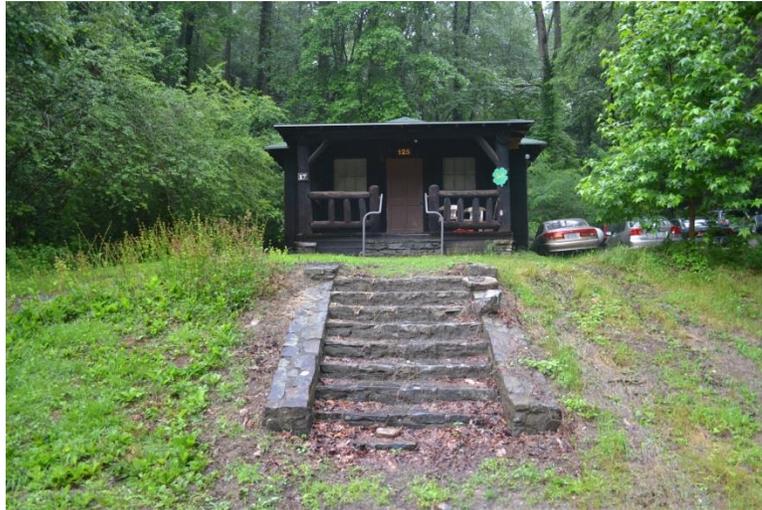
Figure 490. Stone steps at Camp Wahsega.

***Stone features (date undetermined, Category 2).*** Evidence of stone work constructed by the CCC is located throughout the camp, including steps, culverts, and walls. These features survive from the period of significance with sufficient integrity to convey their historic associations. They thus contribute to the significance of a potential National Register historic district. As such, they are assessed as Category 2 resources.

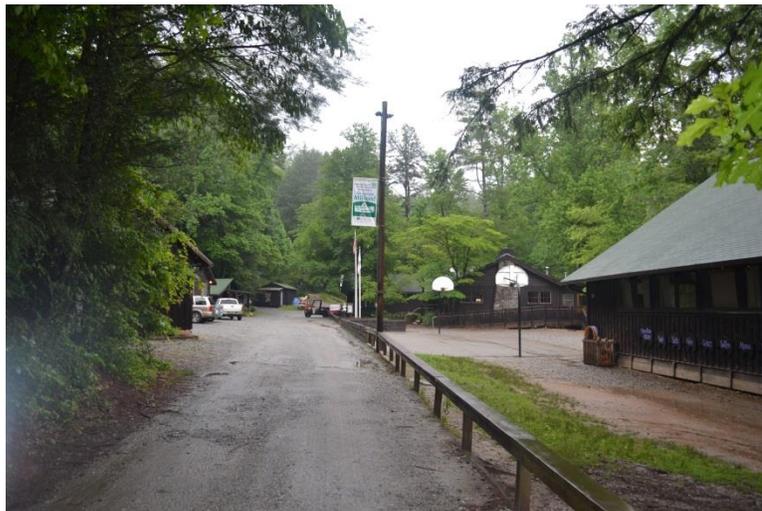
Figure 491. The camp access road.

***Access road (date undetermined, Category 2).*** This gravel road, referred to as Cloverleaf Trail, arises from Forest Road 28, which continues along the valley to the south. The road provides access to all of the primary buildings that are located in a linear arrangement along both sides of the road. It ends in gravel parking areas. A portion of the road is edged by a wooden post and rail bumper system alongside the recreation field, basketball court, and volleyball court. It

was likely constructed as part of the circa 1938 development of the site. As such, it is assessed as a Category 2 resource.

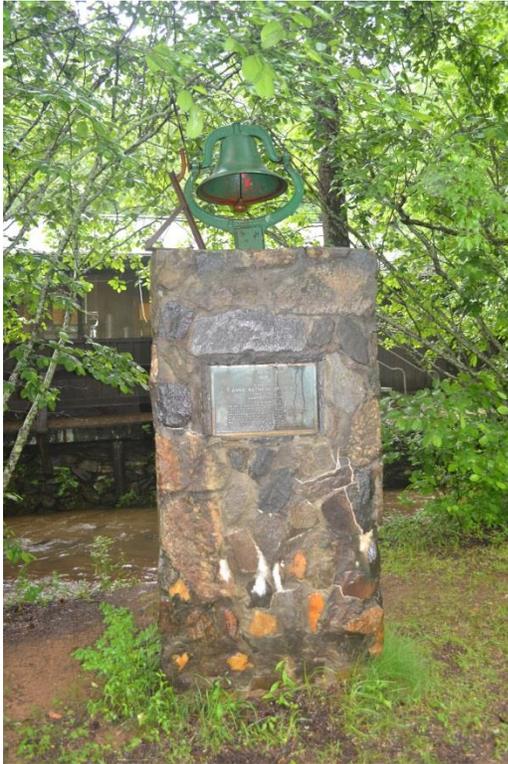
Figure 492. The Andrews bell.

***Andrews bell (1967, Category 4).*** The stone memorial with metal bell was erected in 1967 in honor of camper Kathryn Andrews after her death in 1965. The bell continues to be used to call campers to dinner and other activities. The memorial is sited along Ward Creek.

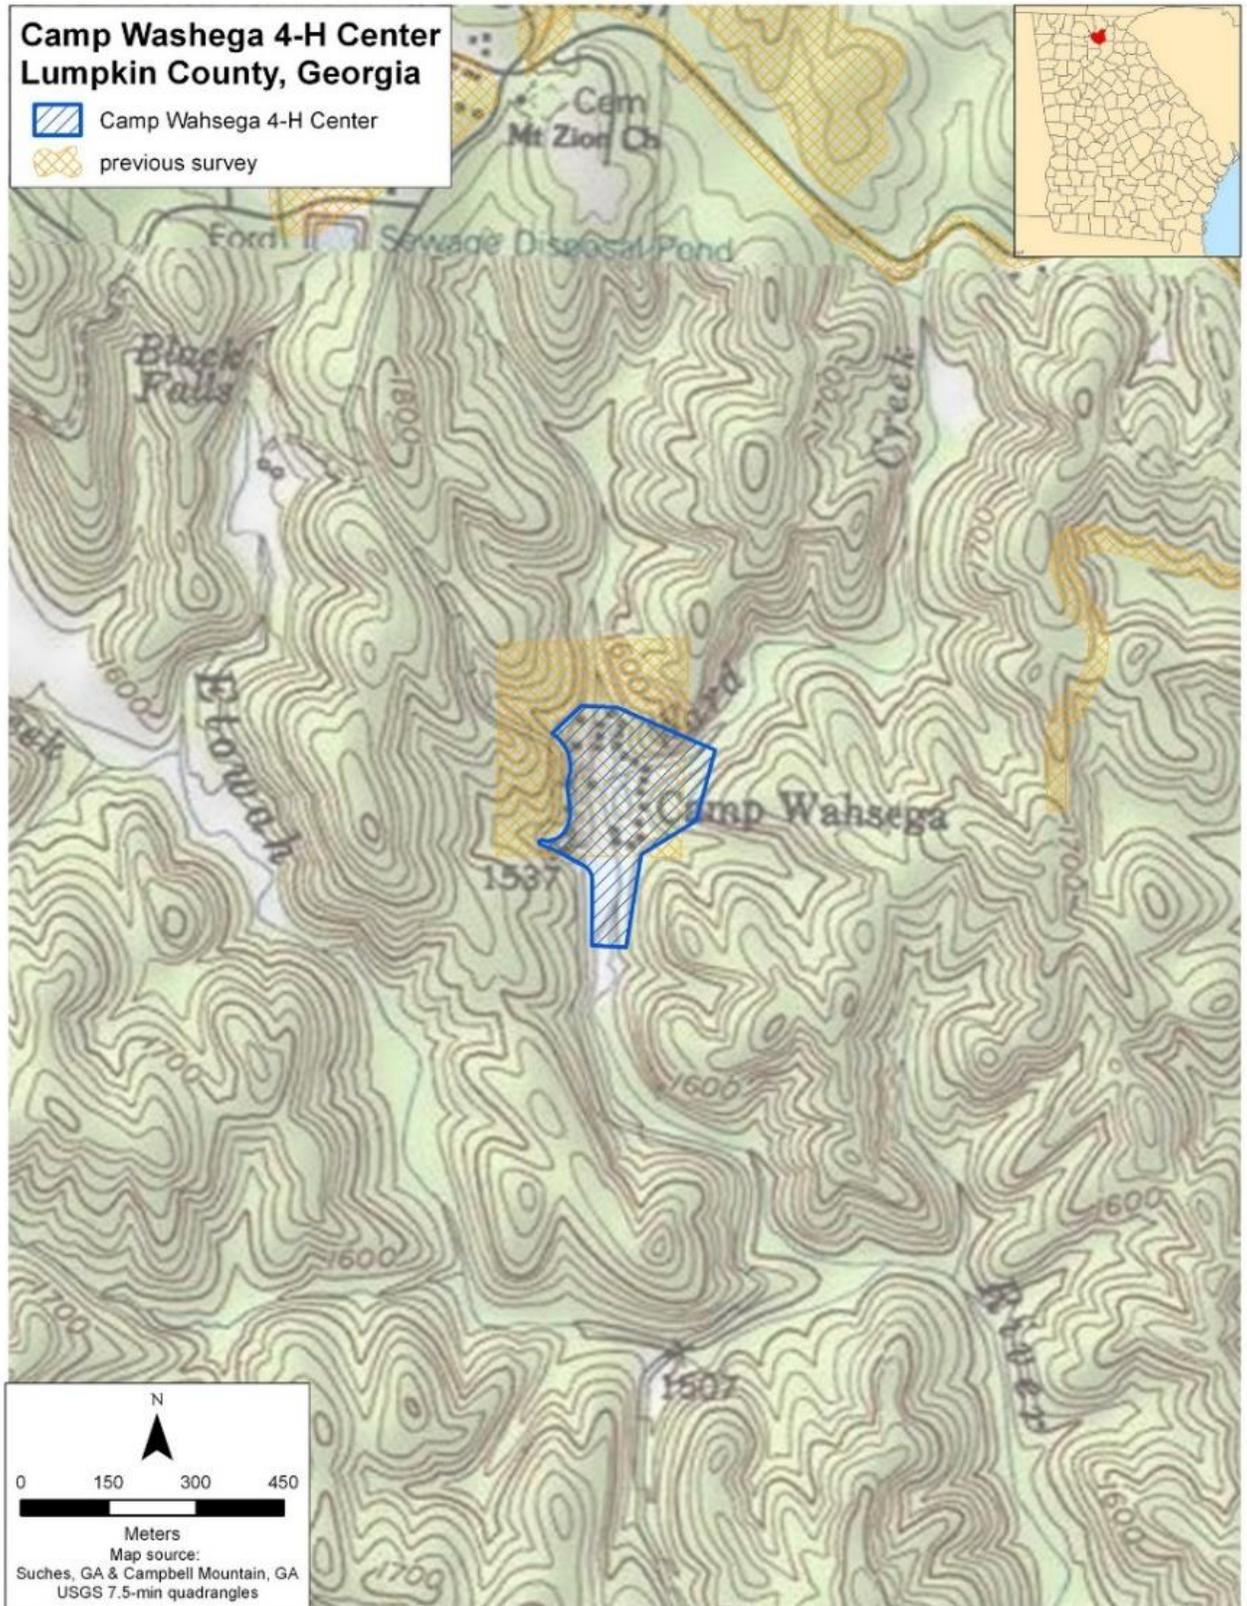
Figure 493. Camp Wahsega 4-H Camp property and area of previous archaeological survey. (Source: USGS, annotated by the authors)

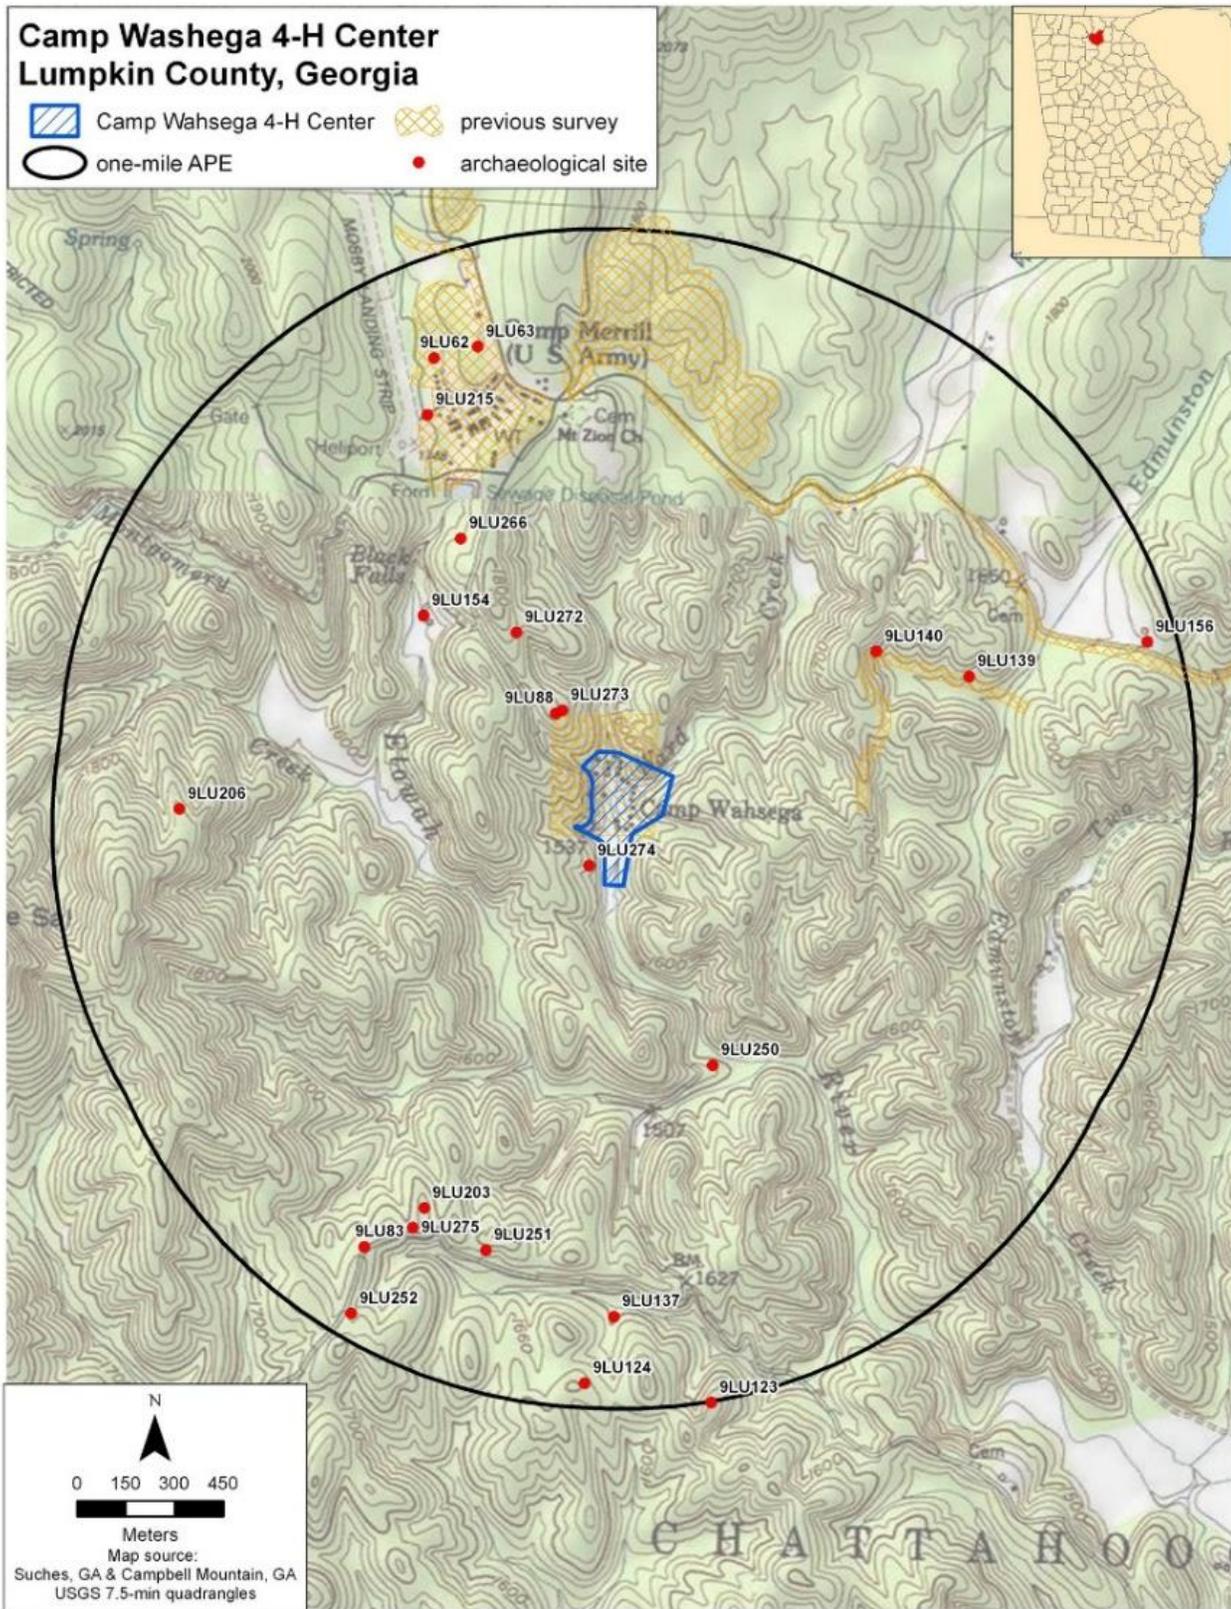
Fig. 496. Camp Wahsega 4-H camp property and area of previous archaeological survey, previously identified archaeological sites, and area of potential effects (APE). (Source: USGS, annotated by authors).
